Culvert Rehab in Indiana

By Eric Kennedy and Alex Sherrod

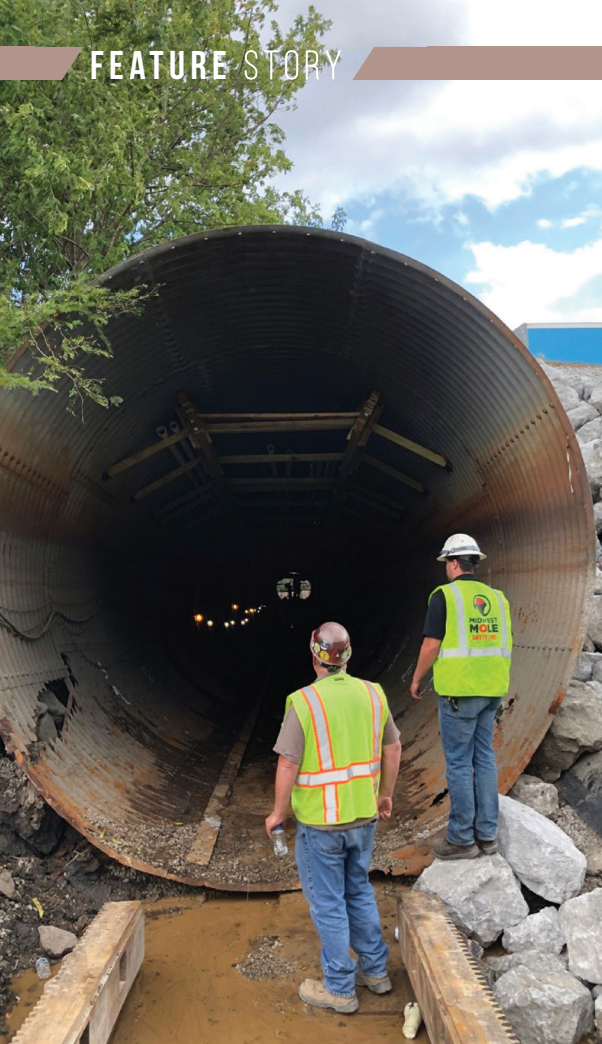
Existing culvert condition prior to rehabilitation.

In 2008, engineers conducted an initial underwater inspection to determine the condition of the culvert structure. Installed in 1965, the structure measured 357-ft long with a 14-ft diameter, and was part of the initial interstate construction. The findings were presented to INDOT noting surface corrosion, steel delamination and pitting, and voids in the culvert structure. Additionally, severe corrosion around the voids allowed back-fill material to migrate under the pipe.

In 2012, a team comprised of INDOT and Parsons Engineering staff, conducted a field inspection noting the deficiencies in the structure. The sight survey included 10 interior measurements taken within the pipe, and the data verified the pipe had settled toward the mid-section, where the weight of the embankment was most severe. Furthermore, the pipe cross section had suffered deformation over the length of the culvert, presenting additional concern of the structural integrity of the pipe.

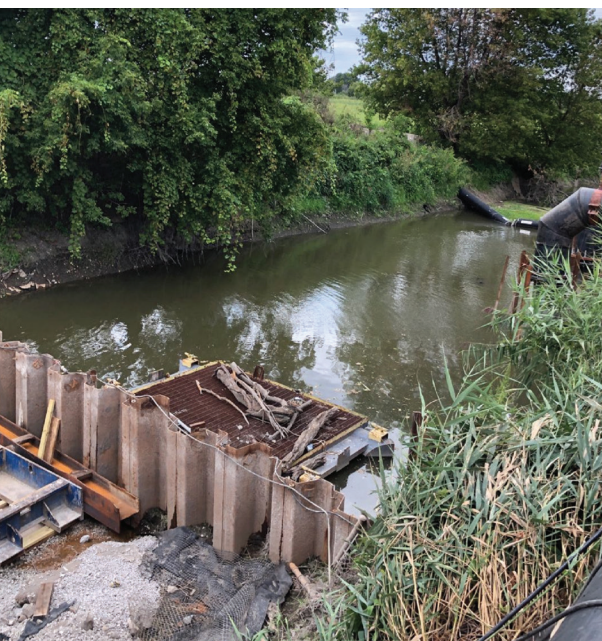
Sheet piling and dam construction prior to slipline rehabilitation.

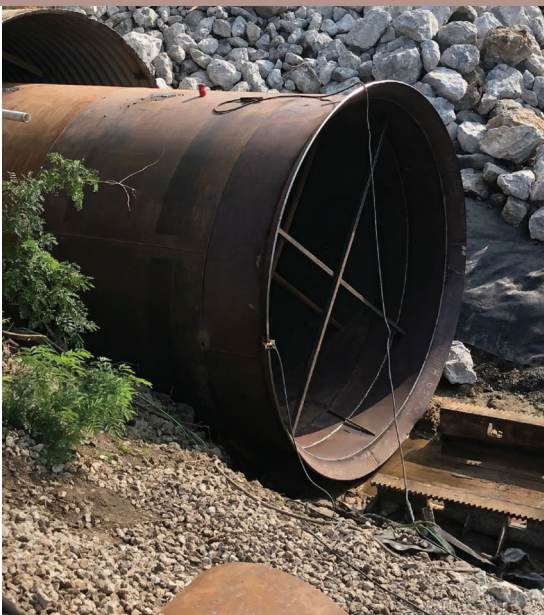
Reducing section, located on upstream end of culvert.

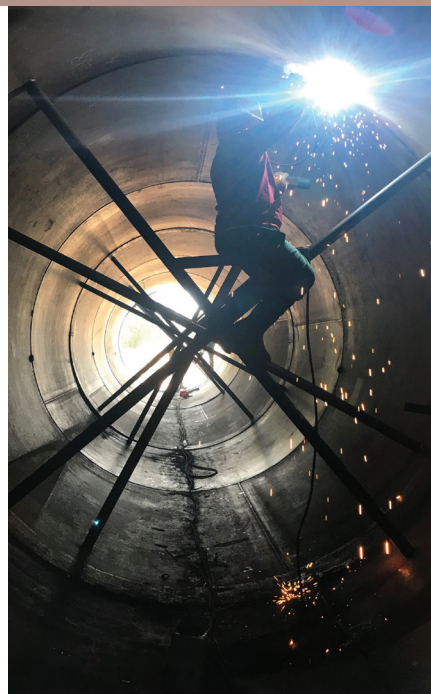
A welder works in the interior of the liner to join liner sections. The full penetration welds limit the possibility of joint failure.

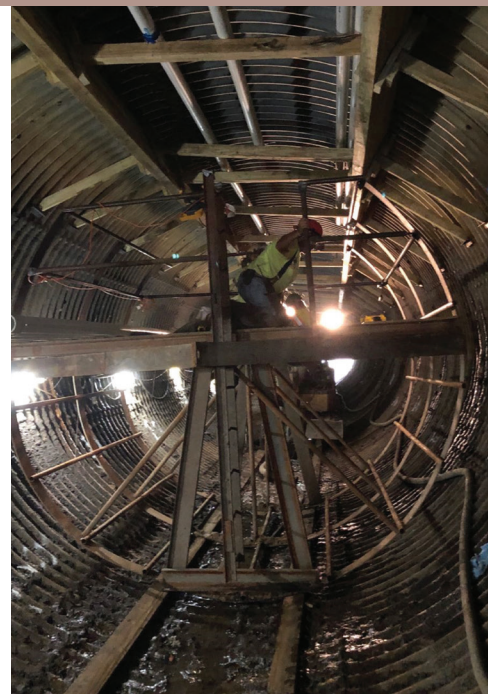
A parallel system of steel channel along the invert and wood forms along the top, kept the liner in place during the installation and grouting phases.
