Culvert Rehab in Indiana

By Eric Kennedy and Alex Sherrod

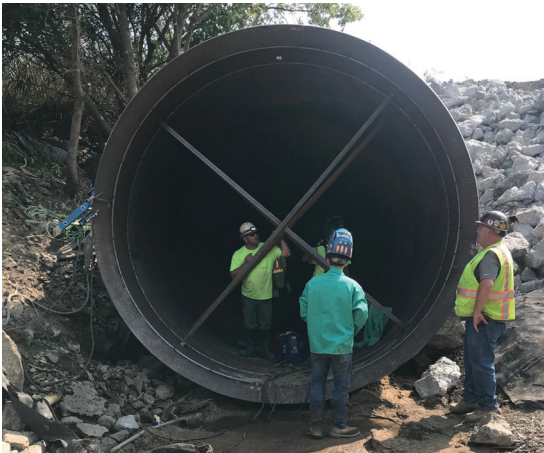
A parallel system of steel channel along the invert and wood forms along the top, kept the liner in place during the installation and grouting phases.
